Field Report  
Avery Landing  
Avery, Idaho

September 19, 2006

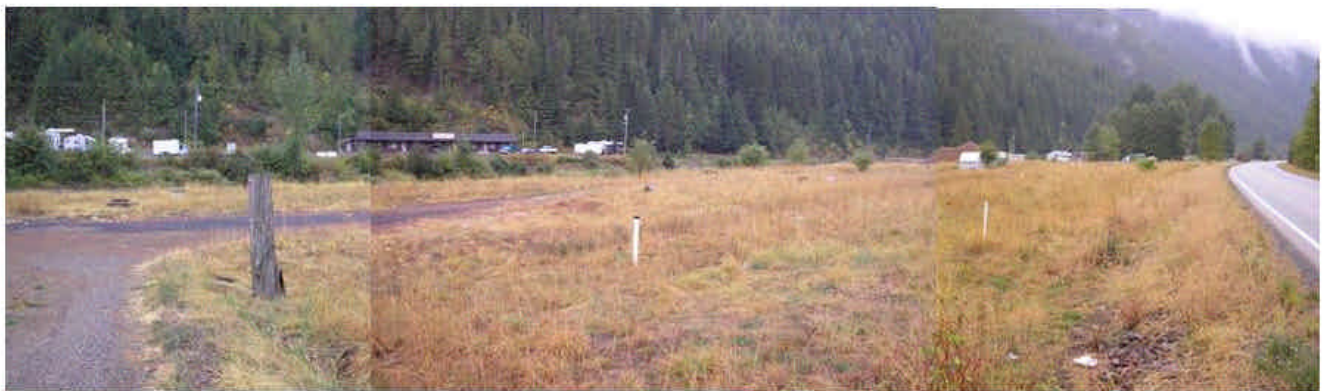
1. The site is unsecured and covered with grass and small shrubs. Two out buildings exist with an above ground tank present. See Figure 1 for photo locations. See Figures 2 -4 for general site conditions
2. A large pile of gravel and crushed rock present. Approximate dimensions 30' length x 15' width x 15' height.
3. Two booms have been deployed in the St. Joe River adjacent to the site, proximate to CW-3. See Figure 5 for location and Figures 6-11 for photos of oil sheen in water.

Figure 2. (Composite photo 1) Looking west to south.

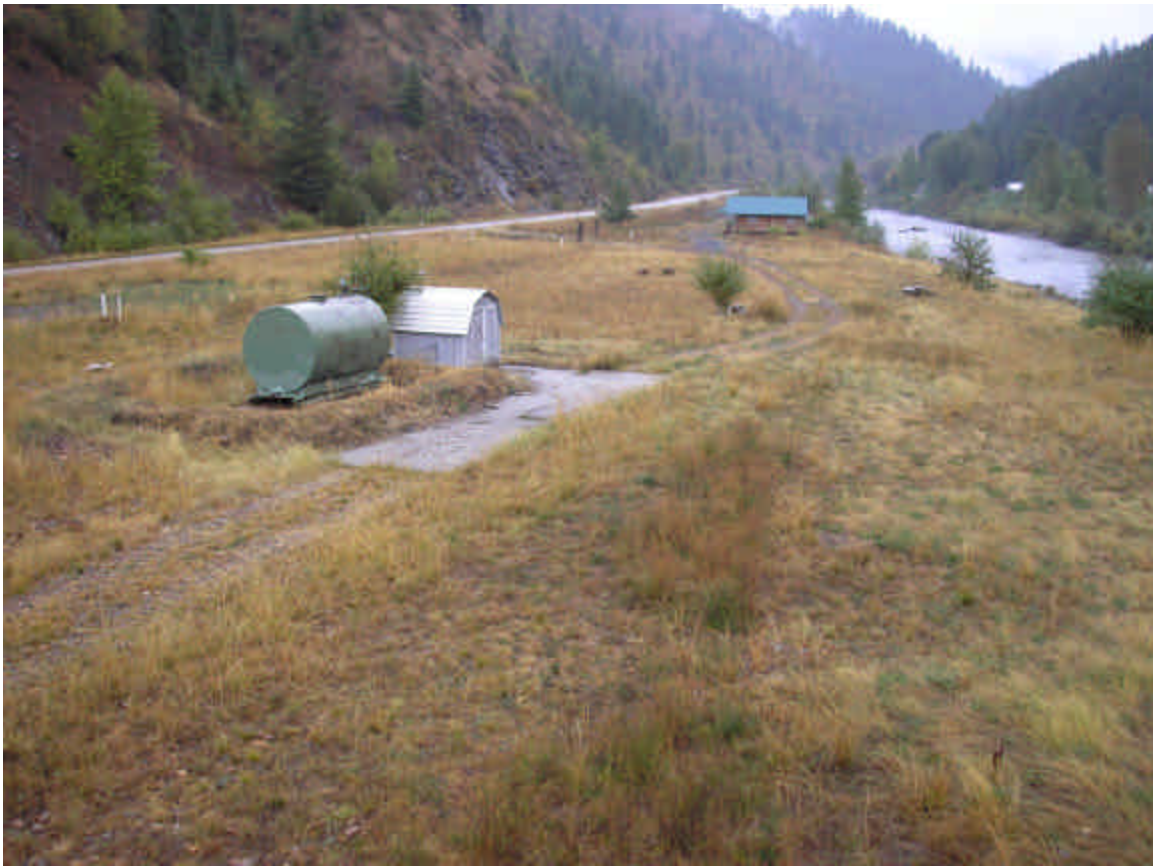
Figure 3. (Photo 2) Looking West to East.

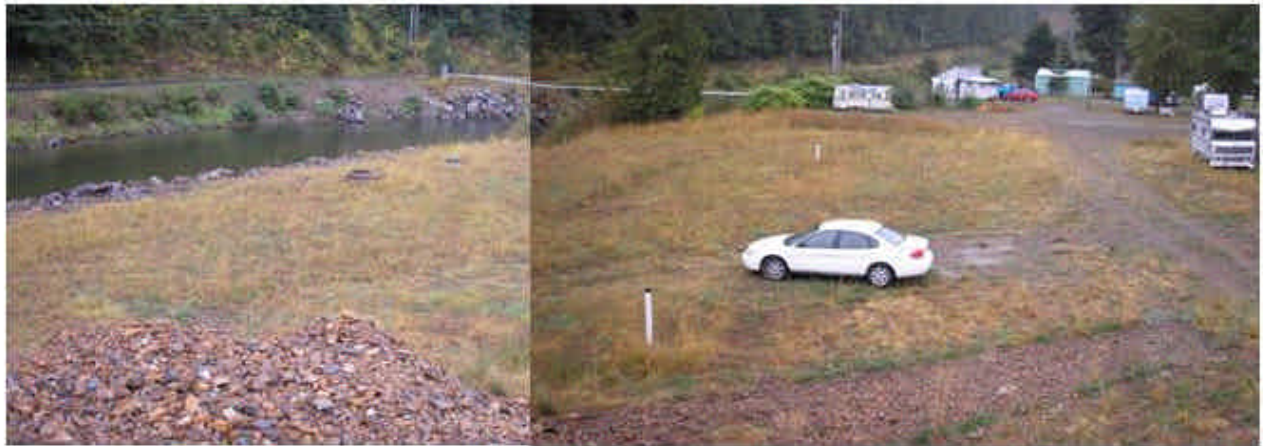
Figure 4. (Composite photo 3) Looking west-southwest

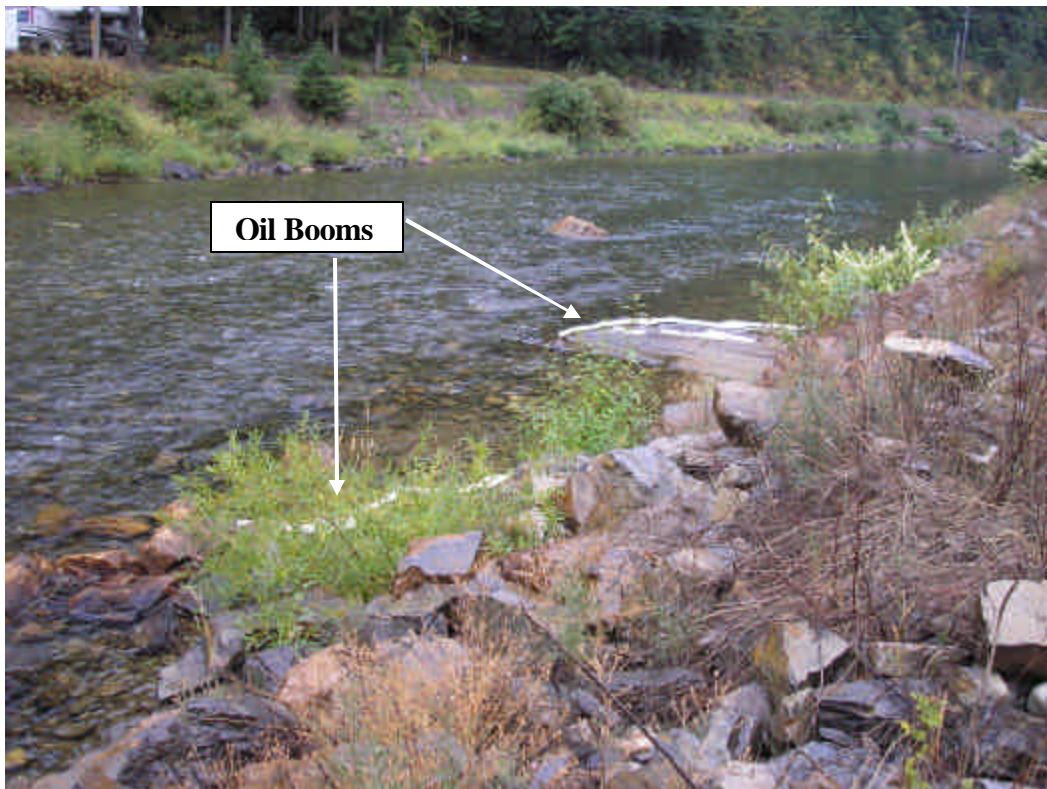
Figure 6. (Photo 4) Oil booms deployed on the St. Joe River

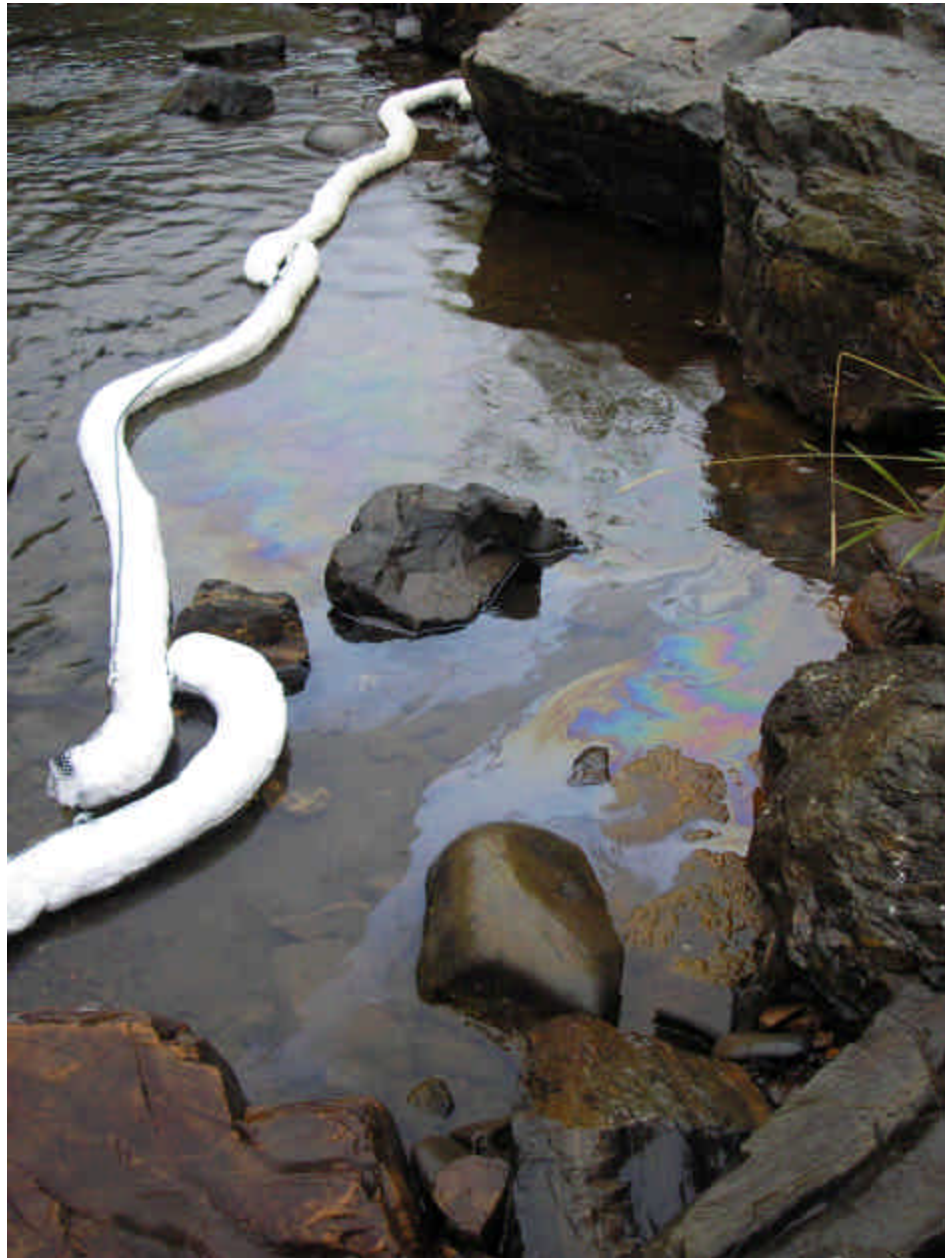
East Booms - There is a heavy sheen on the water with color grading from iridescent to gray. Sheen appears from heavy oil, distinct globules form in some areas. There is some oil leaking from boom containment.

Figure 7. (Photo 5) East boom with heavy sheen in water.

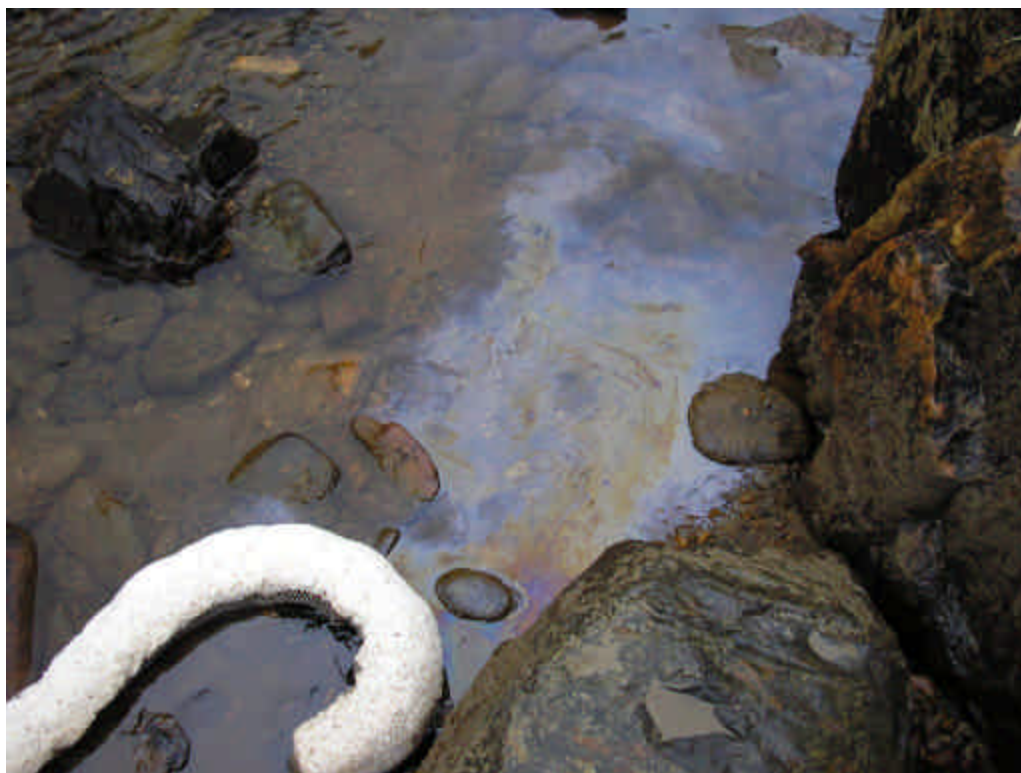
Figure 8. (Photo 6) Oil leaking from east boom into St. Joe River.

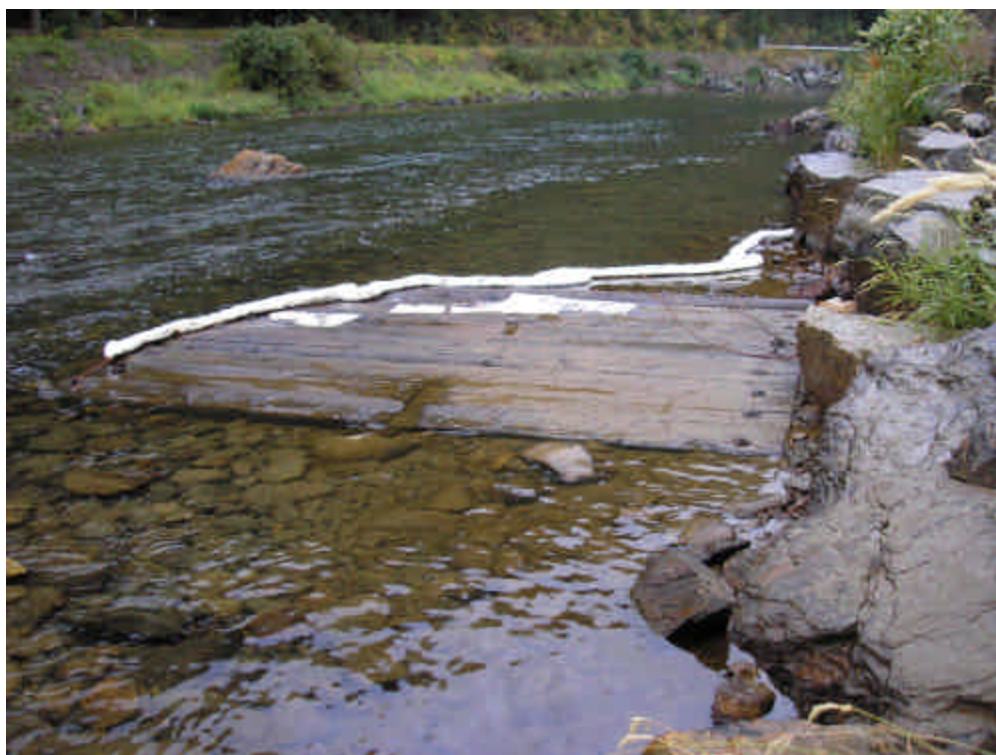
West Booms – There is slight sheen with grayish color, distinct globules form in some areas. Some adsorbent pads have also been deployed

Figure 9. (Photo 7) West oil booms in St. Joe River. Wooden dock in foreground.

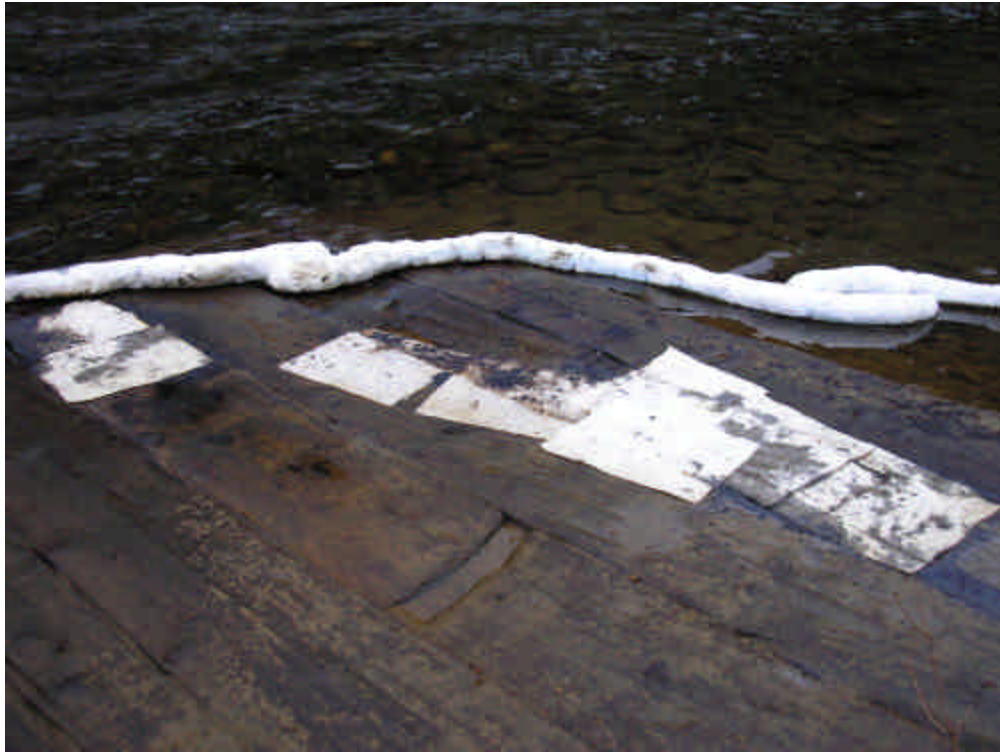
Figure 10. (Photo 8) Oil and adsorbent pads on wooden dock structure

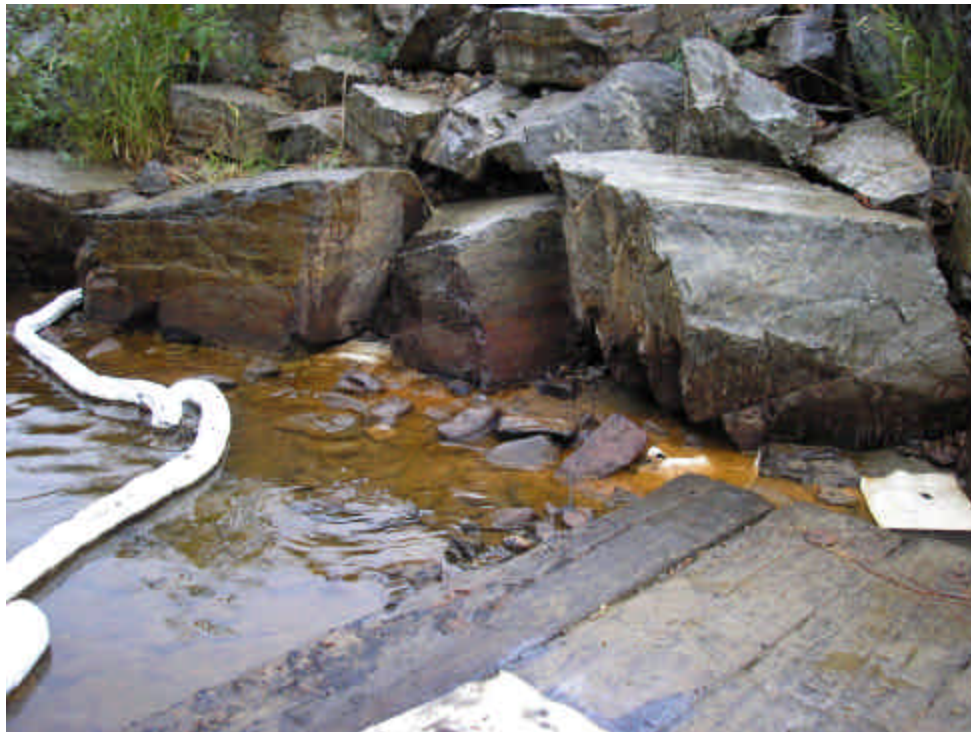
4. Significant iron staining noted on shore adjacent to west booms. Most likely indicates consistent petroleum leak from area.
5. A number of wells are unsecured with the top easily removed. These wells appear to include: EW -1, EW -3, TP-7, TP-9, TP-10, and TP-11.

Figure 11. (Photo 9) Iron staining adjacent to St. Joe River.
